BUREAU OF SHIPS GROUP
TECHNICAL INSPECTION REPORT

⑥ OPERATION CROSSROADS.
U.S.S HUGHES (DD410).
TEST BAKER.

VOLUME II [u] ⑧

USS HUGHES (DD410)

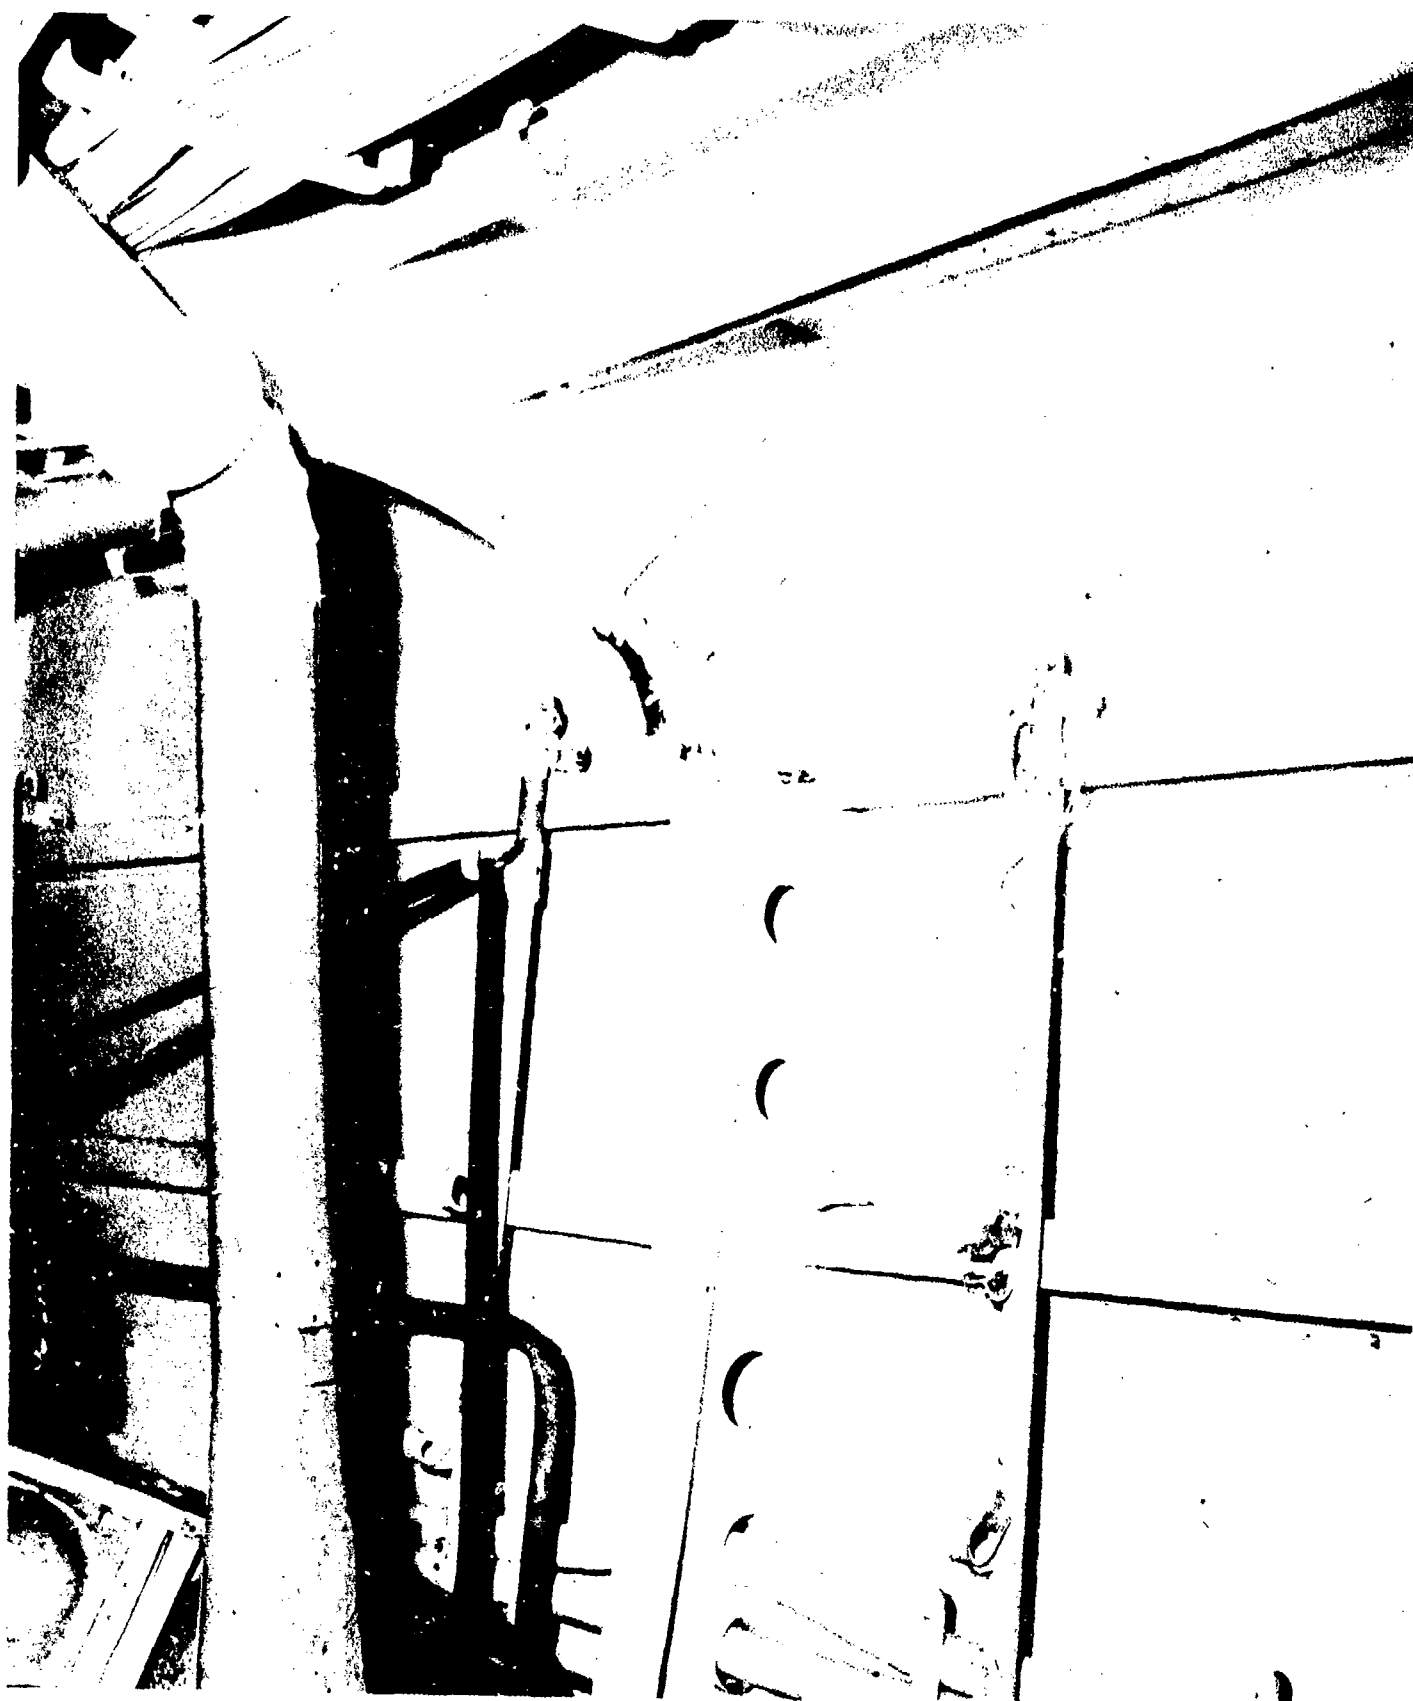
AB-CR-100-4208-8. Damaged web frame 179, port looking aft on first platform in crews quarters.

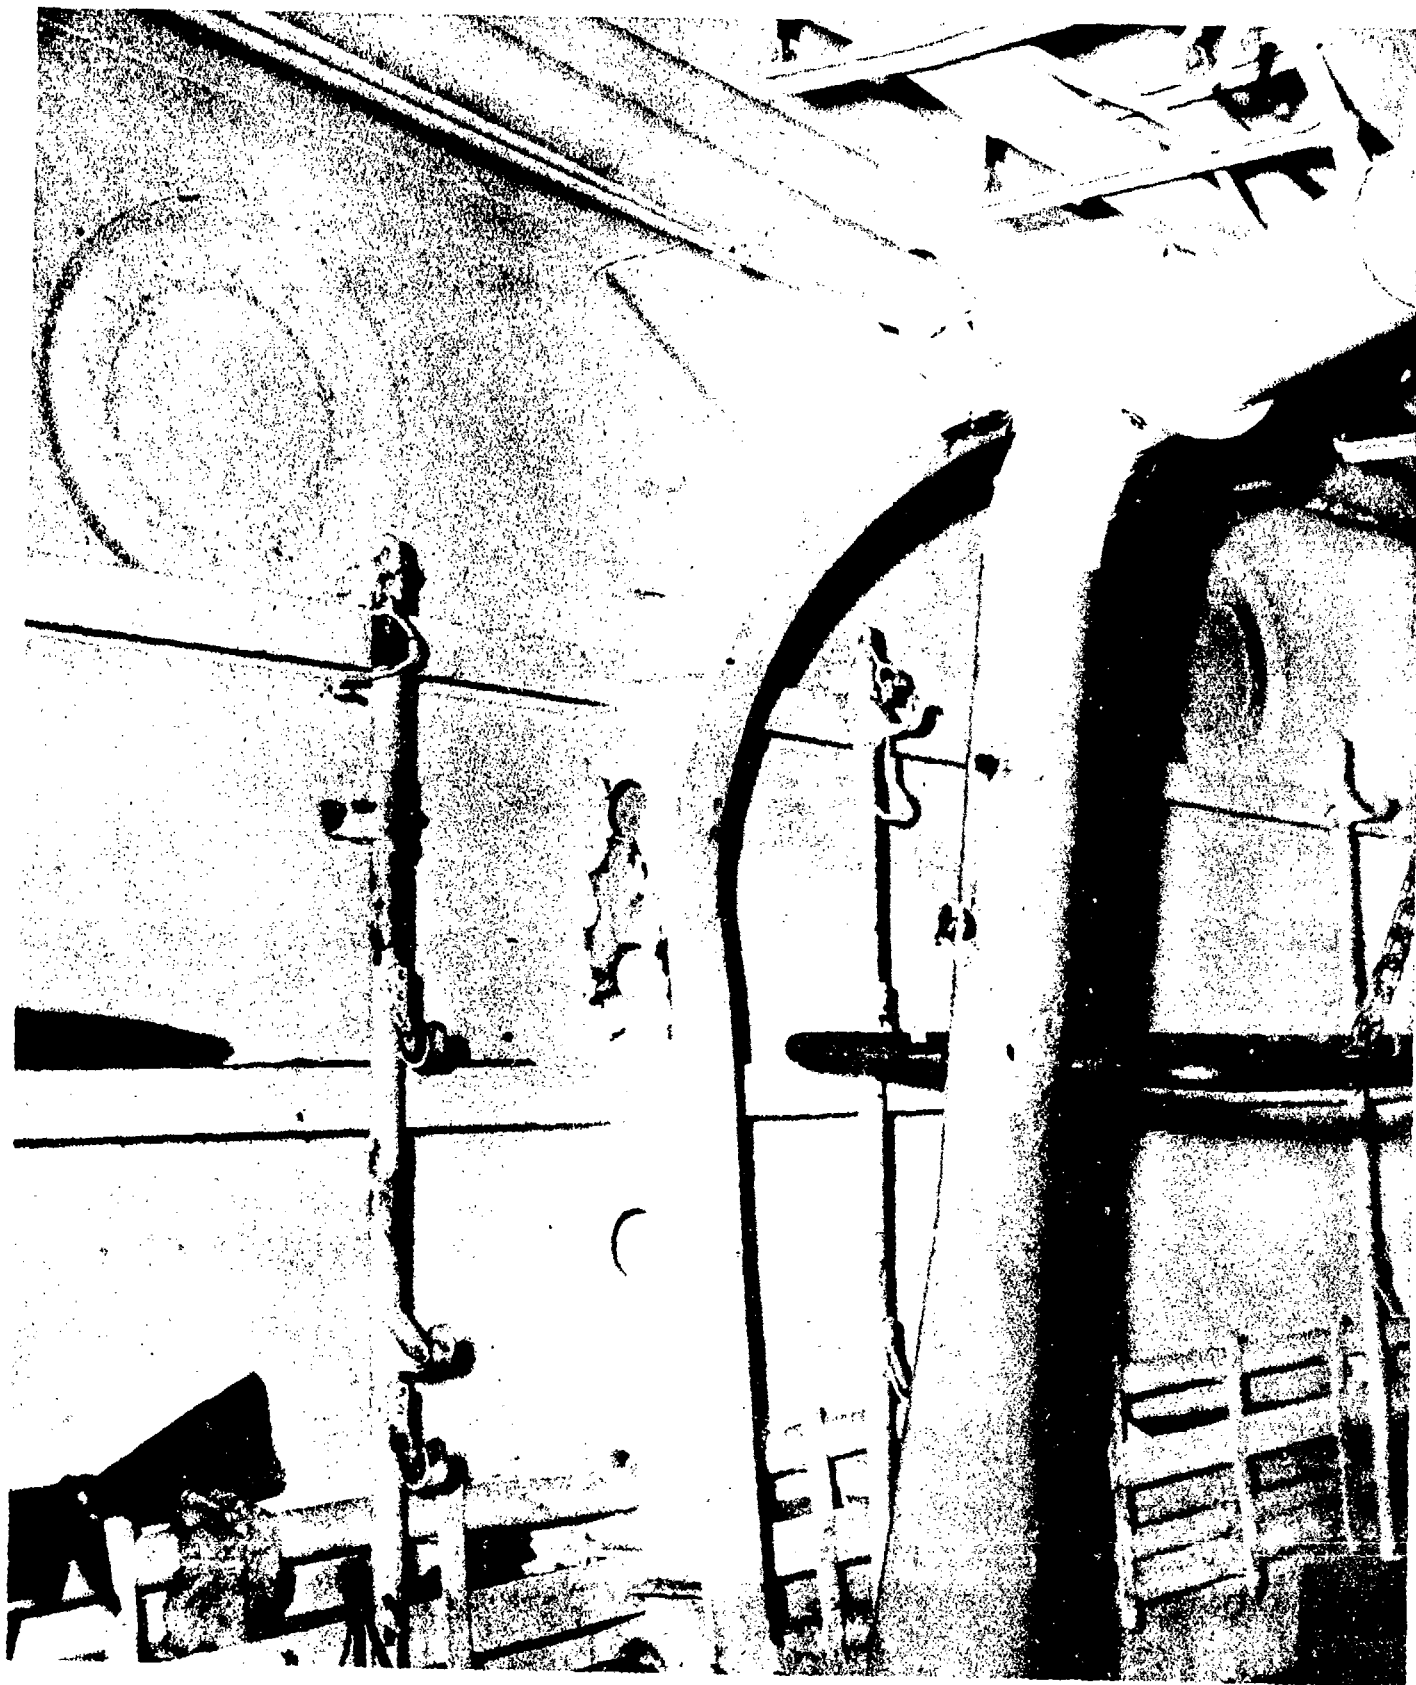
AB-CR-100-4208-5. Damaged web frame 179, starboard side looking aft on first platform in crews quarters.

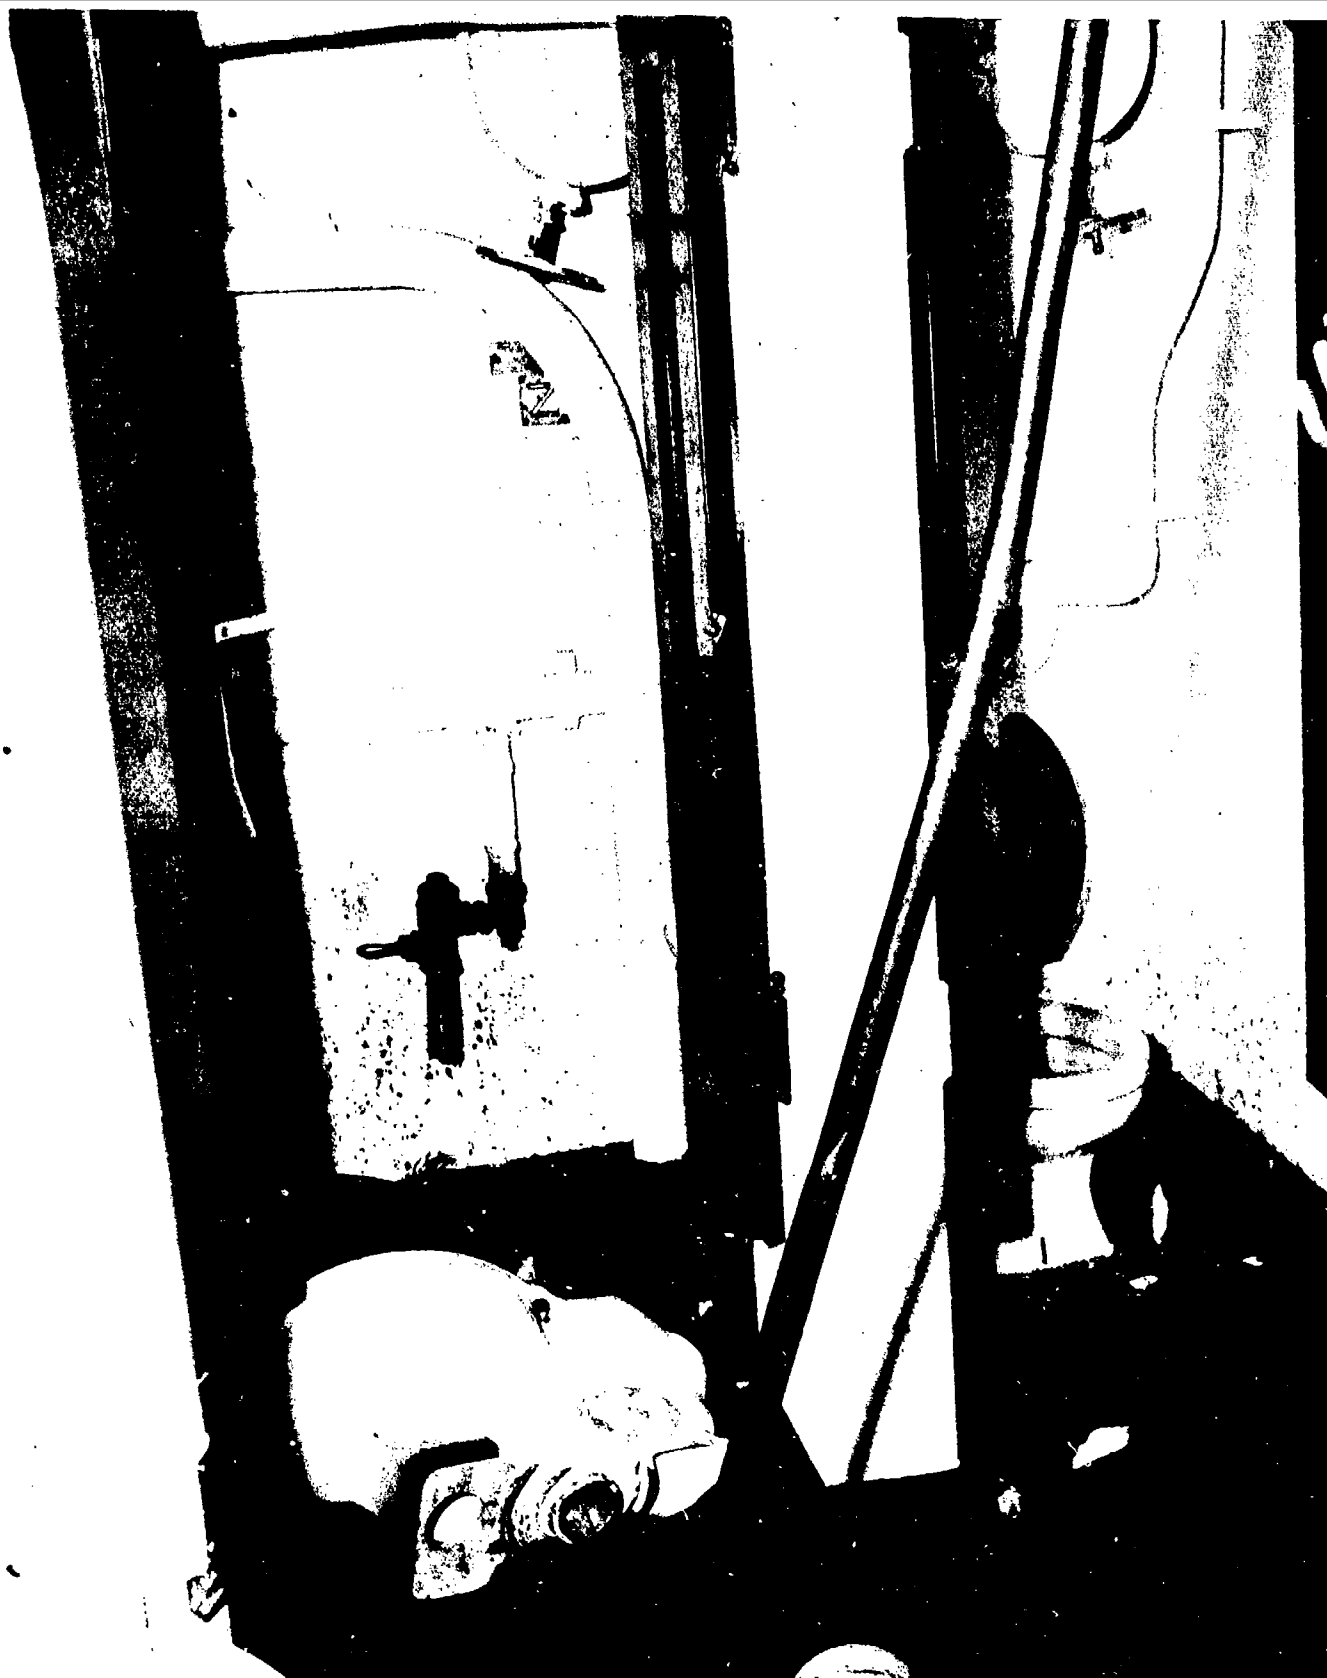
AB-CR-100-4211-4. Looking forward on main deck port side, to bulkhead 25 showing broken toilet bowl, piping and ammunition cans.

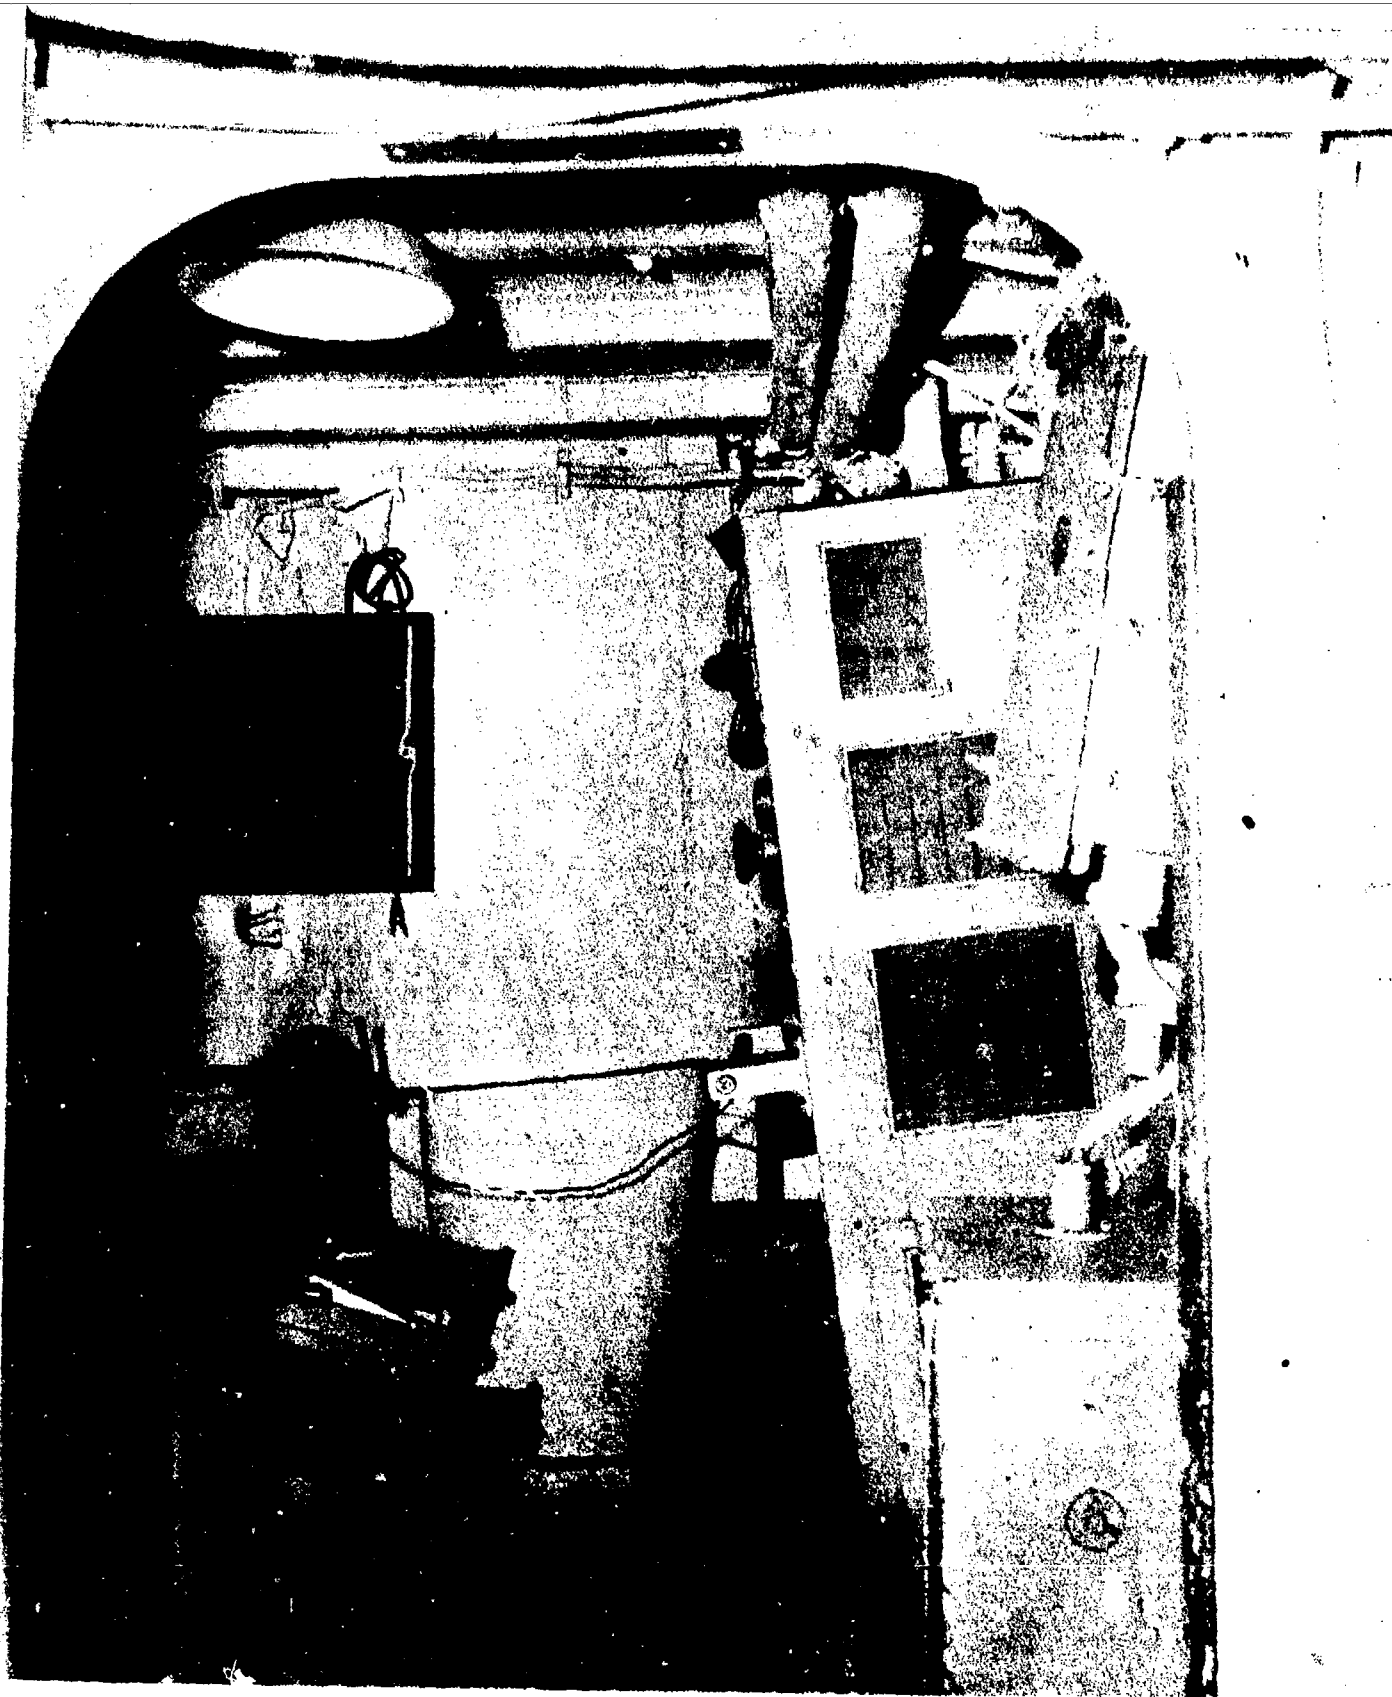
AB-CR-100-4204-7. Equipment damage in electrical workshop on main deck starboard side looking aft through arch at frame 106.

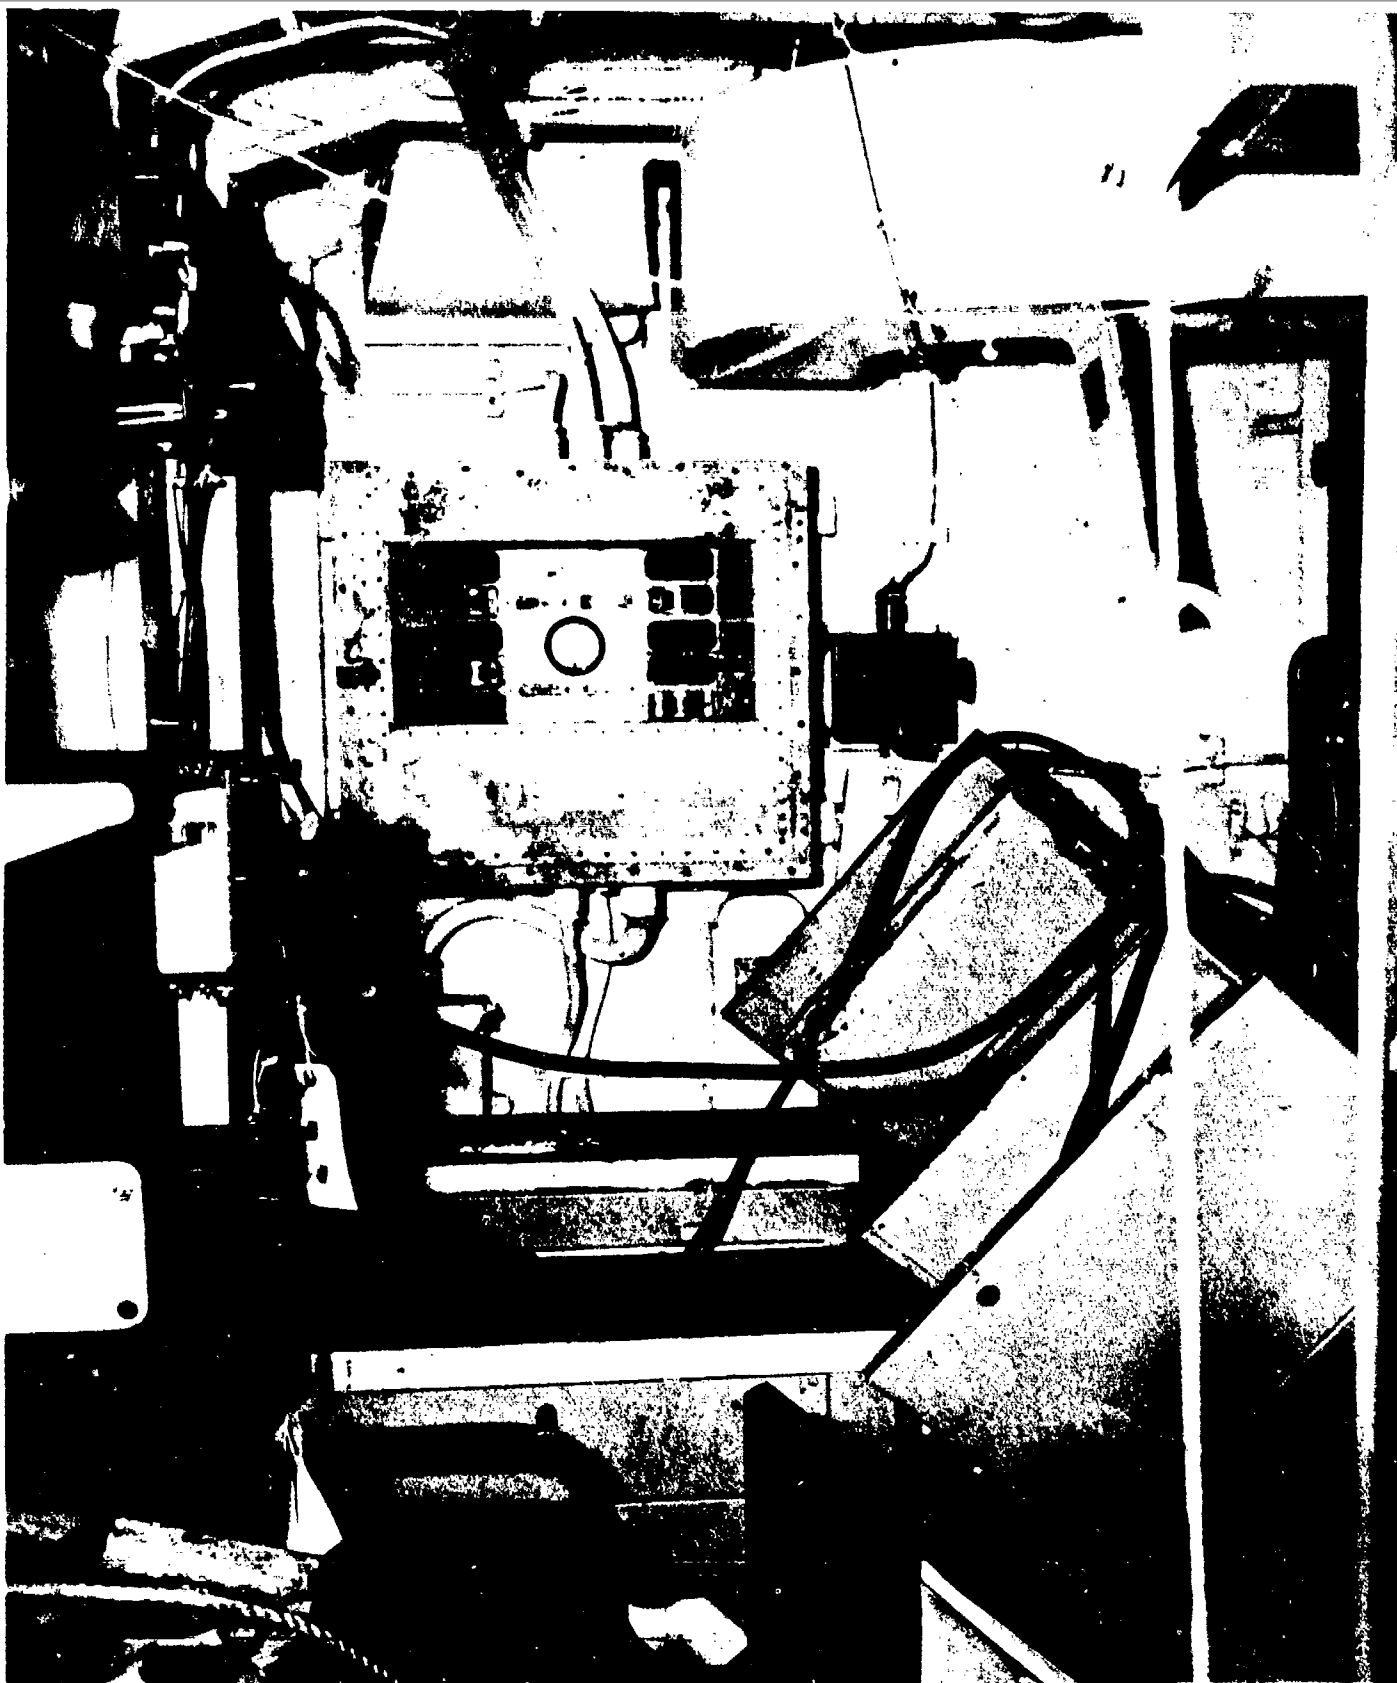
AB-CR-100-4204-9. Equipment damage in emergency radio room B-107C, looking forward on main deck to bulkhead 131.

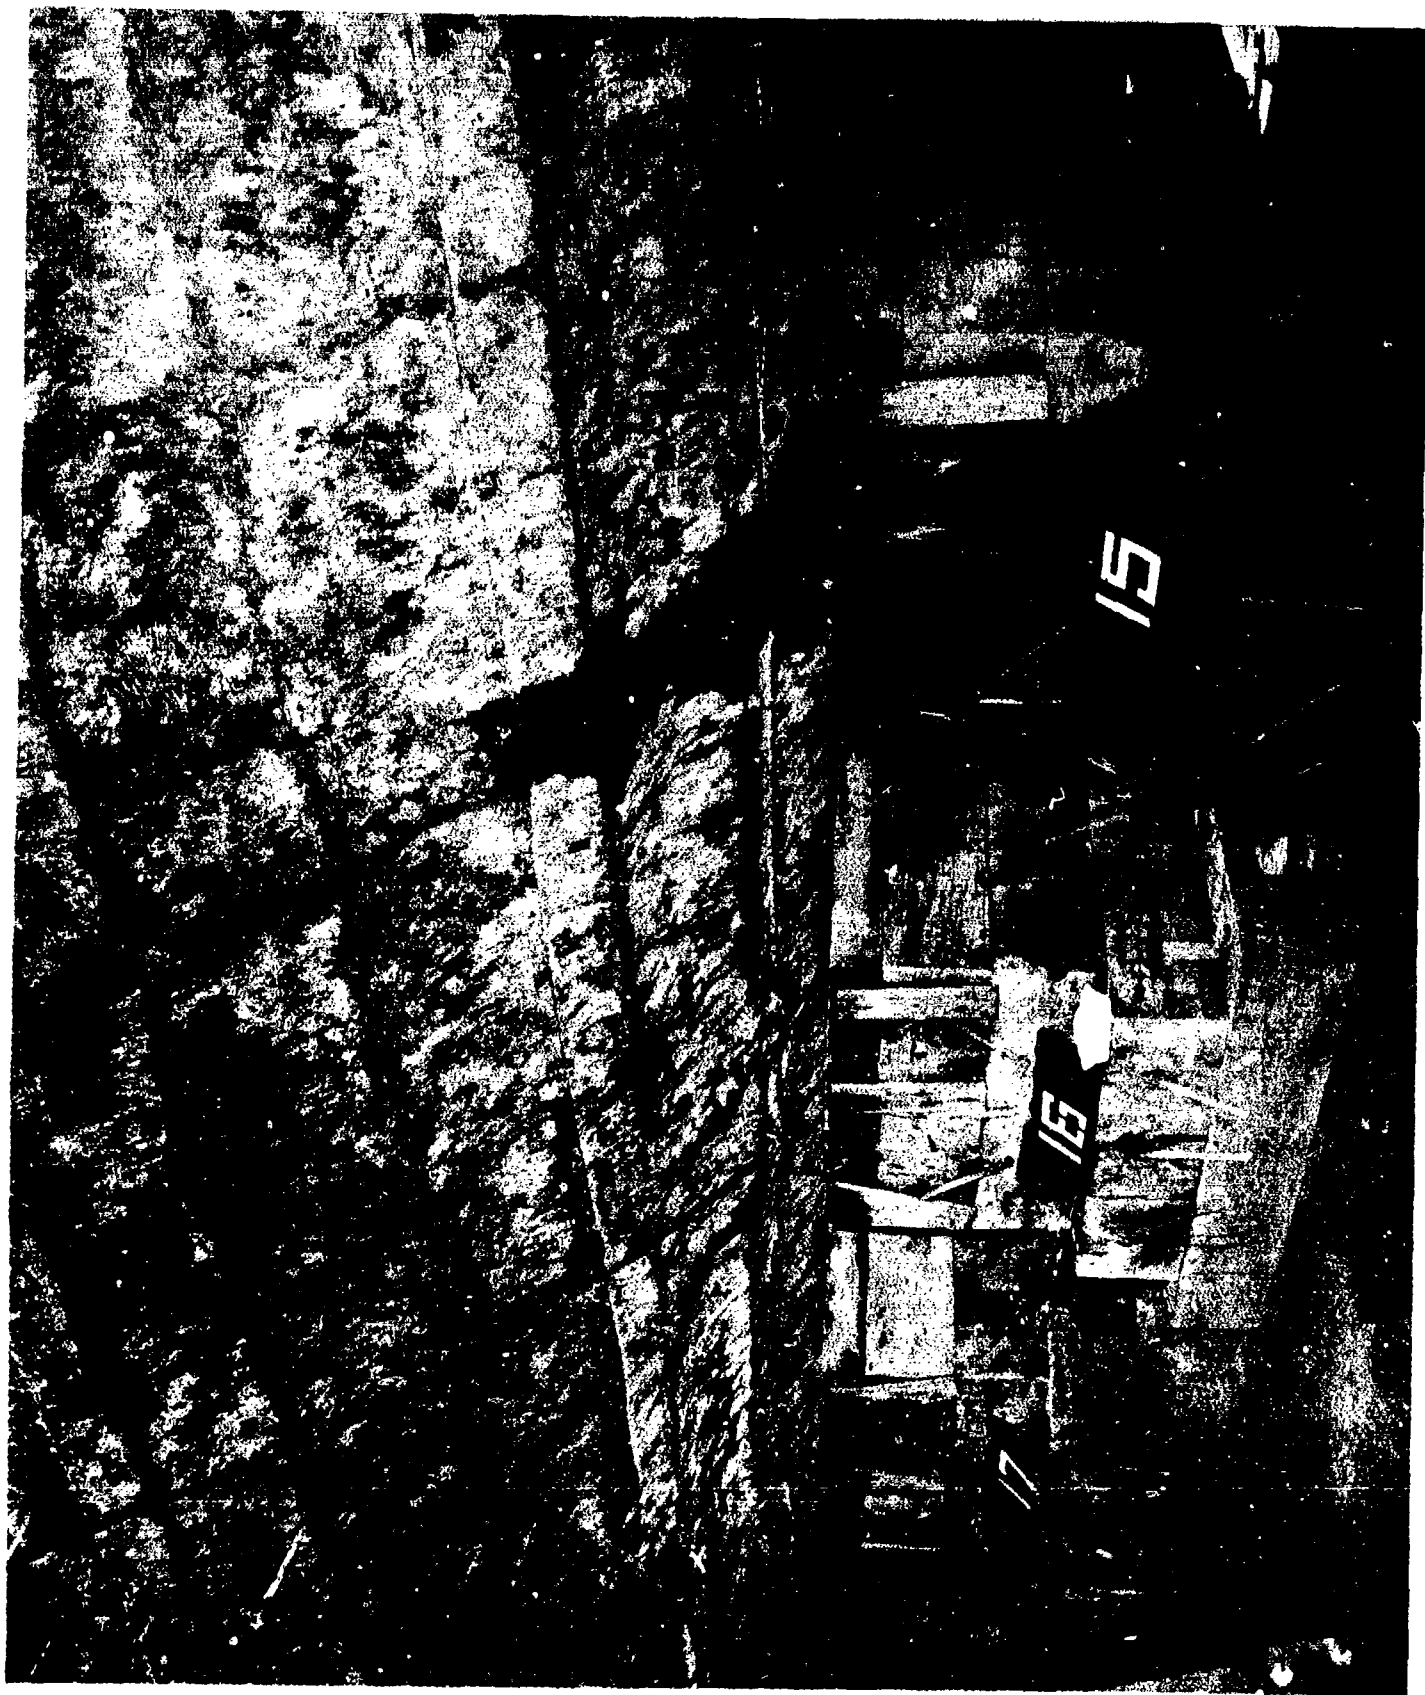
AB-CR-97-4050-3. Starboard bottom shell looking inboard and aft, frames 36 to 40, in way of severe grounding damage superimposed upon washboarding due to underwater shock wave.

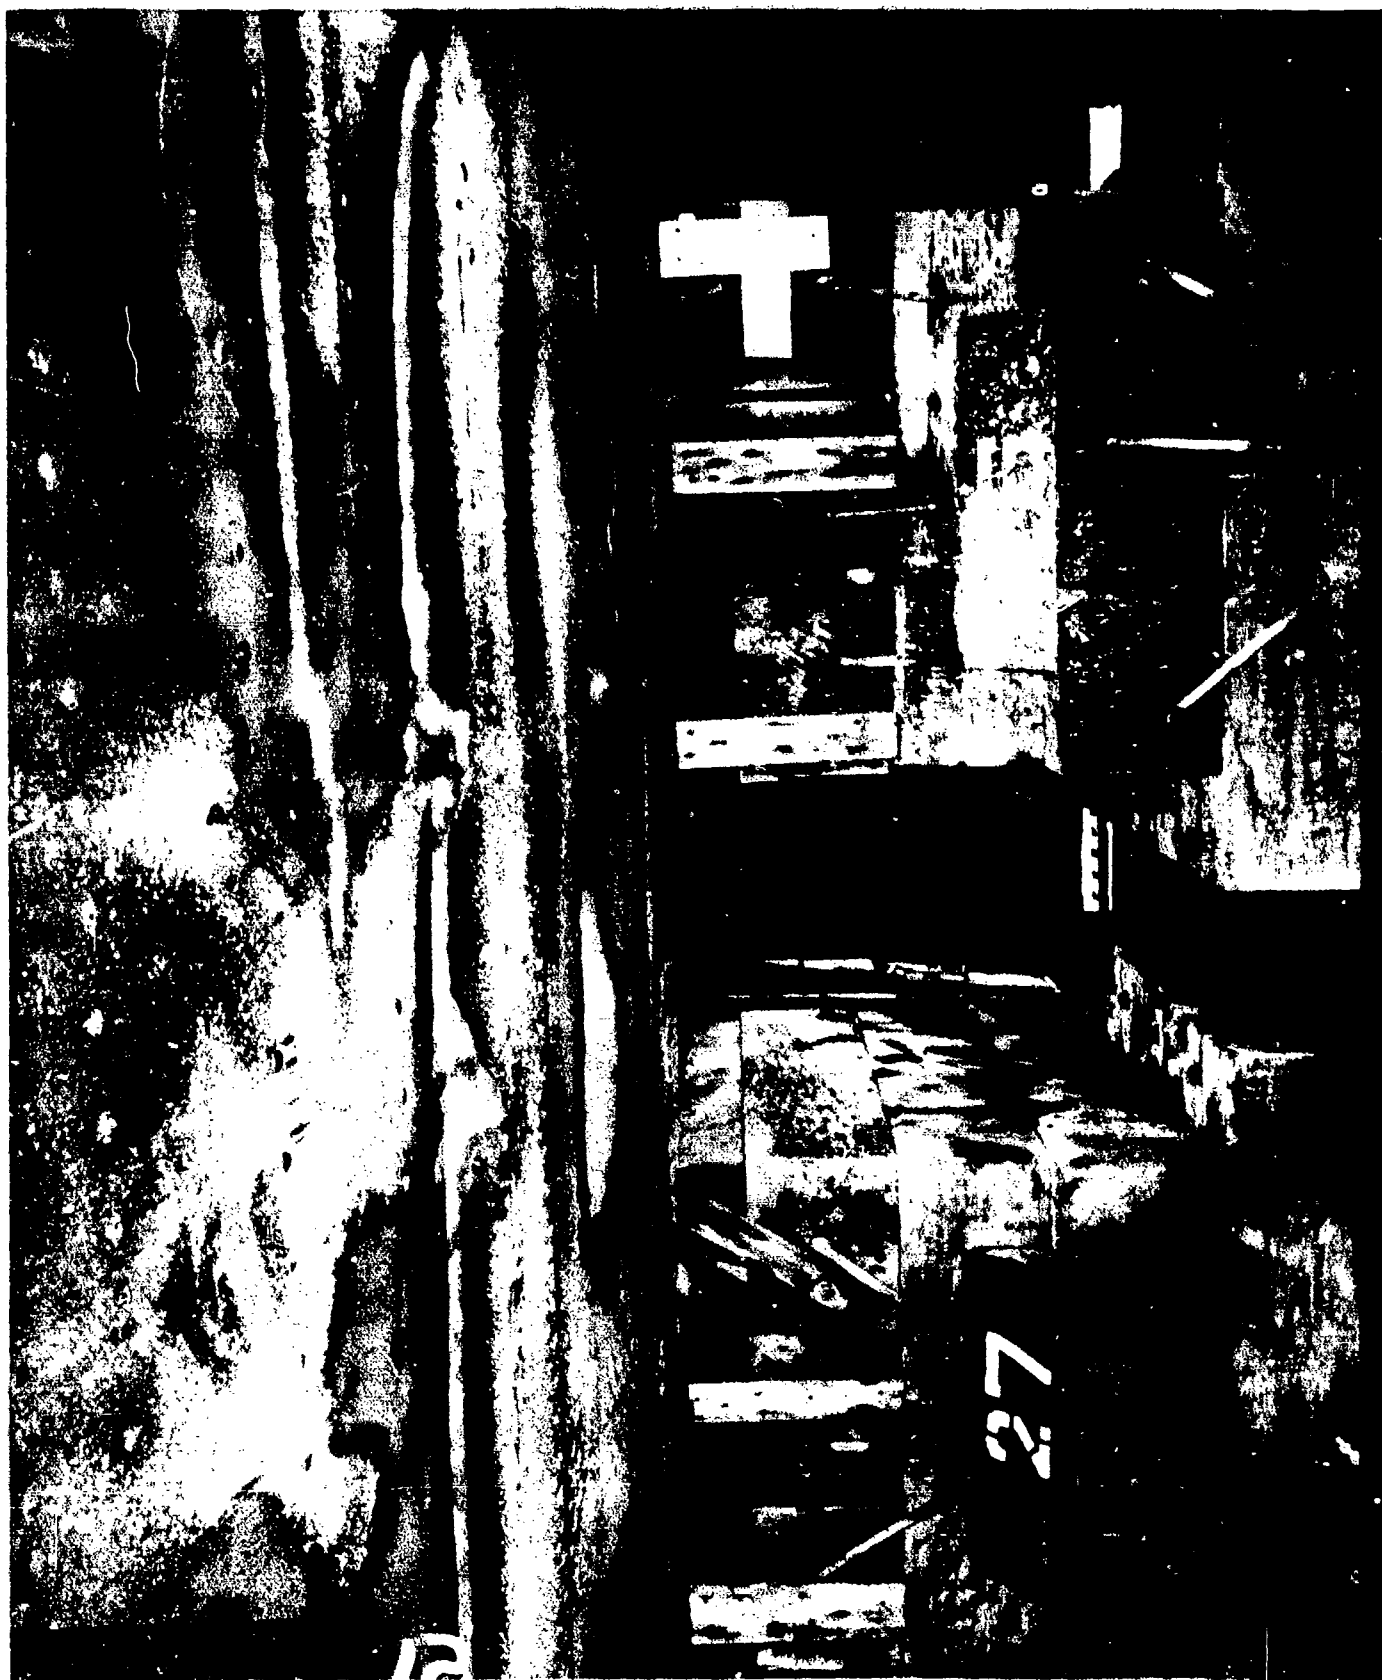
AB-CR-97-4049-12. Starboard bottom shell, looking inboard at frame 78. Note longitudinal dishing, probably due to grounding damage.

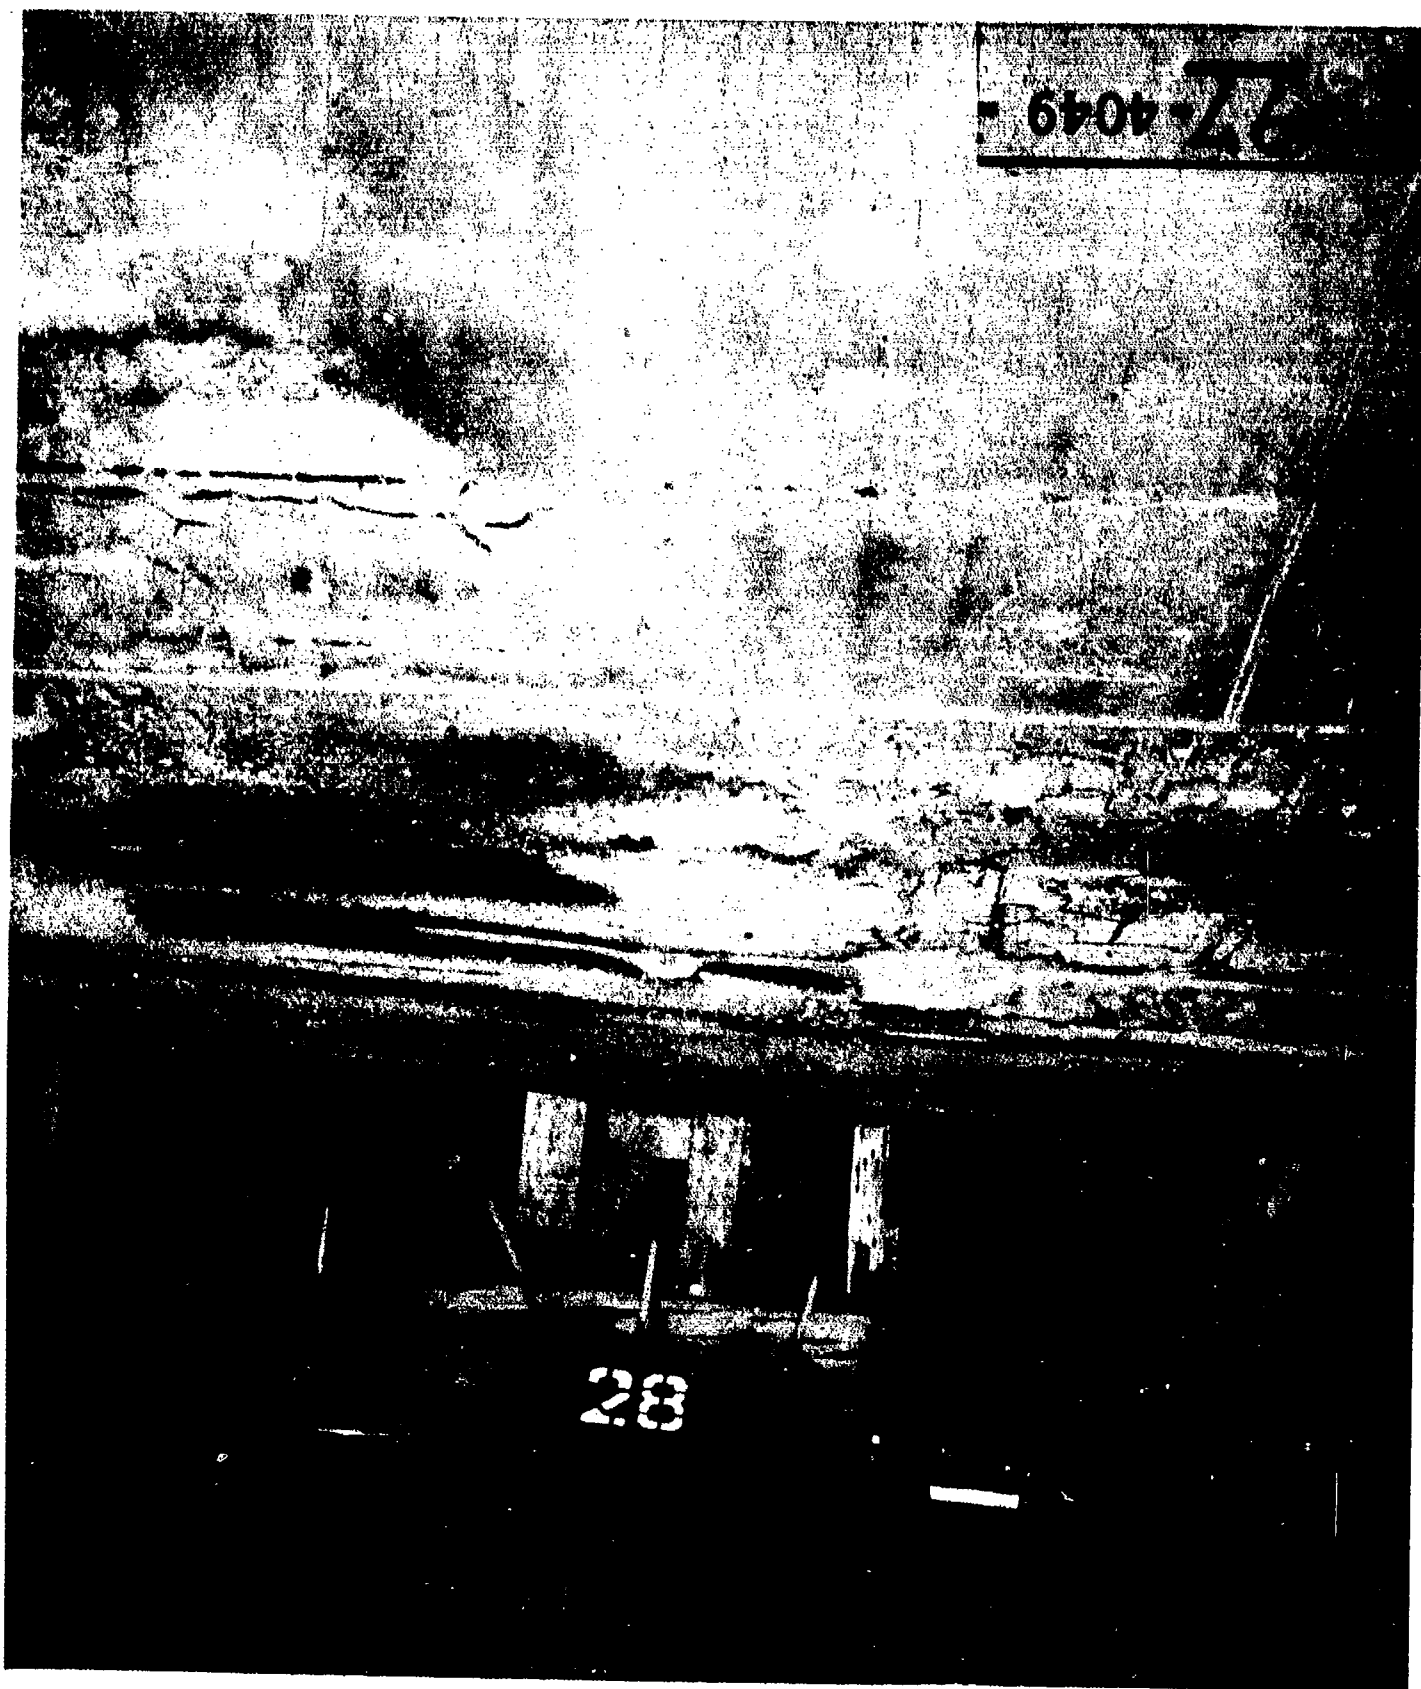
AB-CR-97-4049-11. Starboard bottom shell, looking inboard at frame 82 grounding damage.

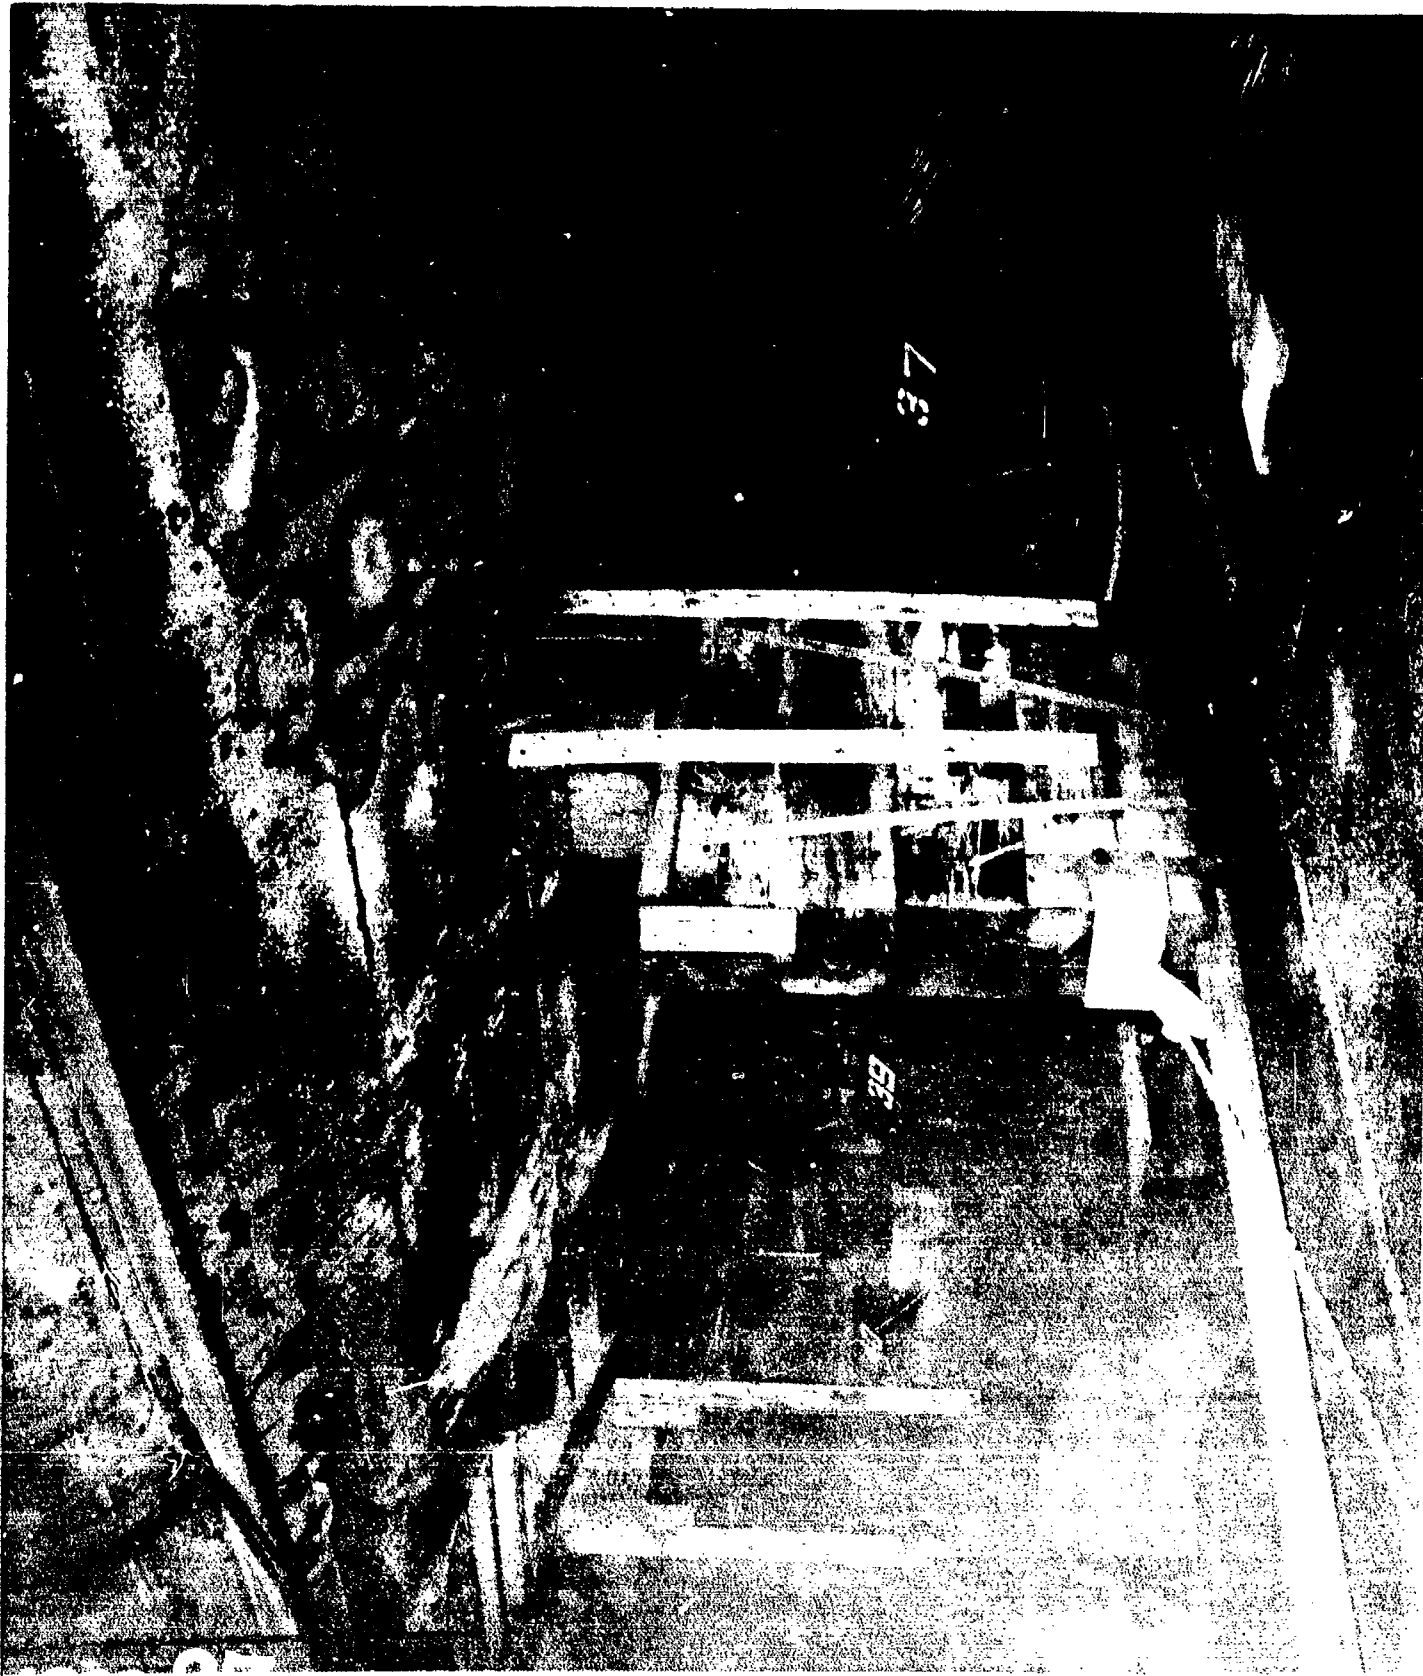
AB-CR-97-4049-9. Starboard bottom shell, looking inboard and aft, frames 108-120. The right half of B strake is dimpled and the plastic coating has been worn off in contact with the coral during grounding.
